# THE GROUTING OF LOW PERMEABILITY SOILS IN DAM FOUNDATIONS

by David M Brett B.E., M.I.E. (Aust)

A thesis submitted in fulfilment of the requirements of the degree of Master of Engineering, at the University of Tasmania, 1985.

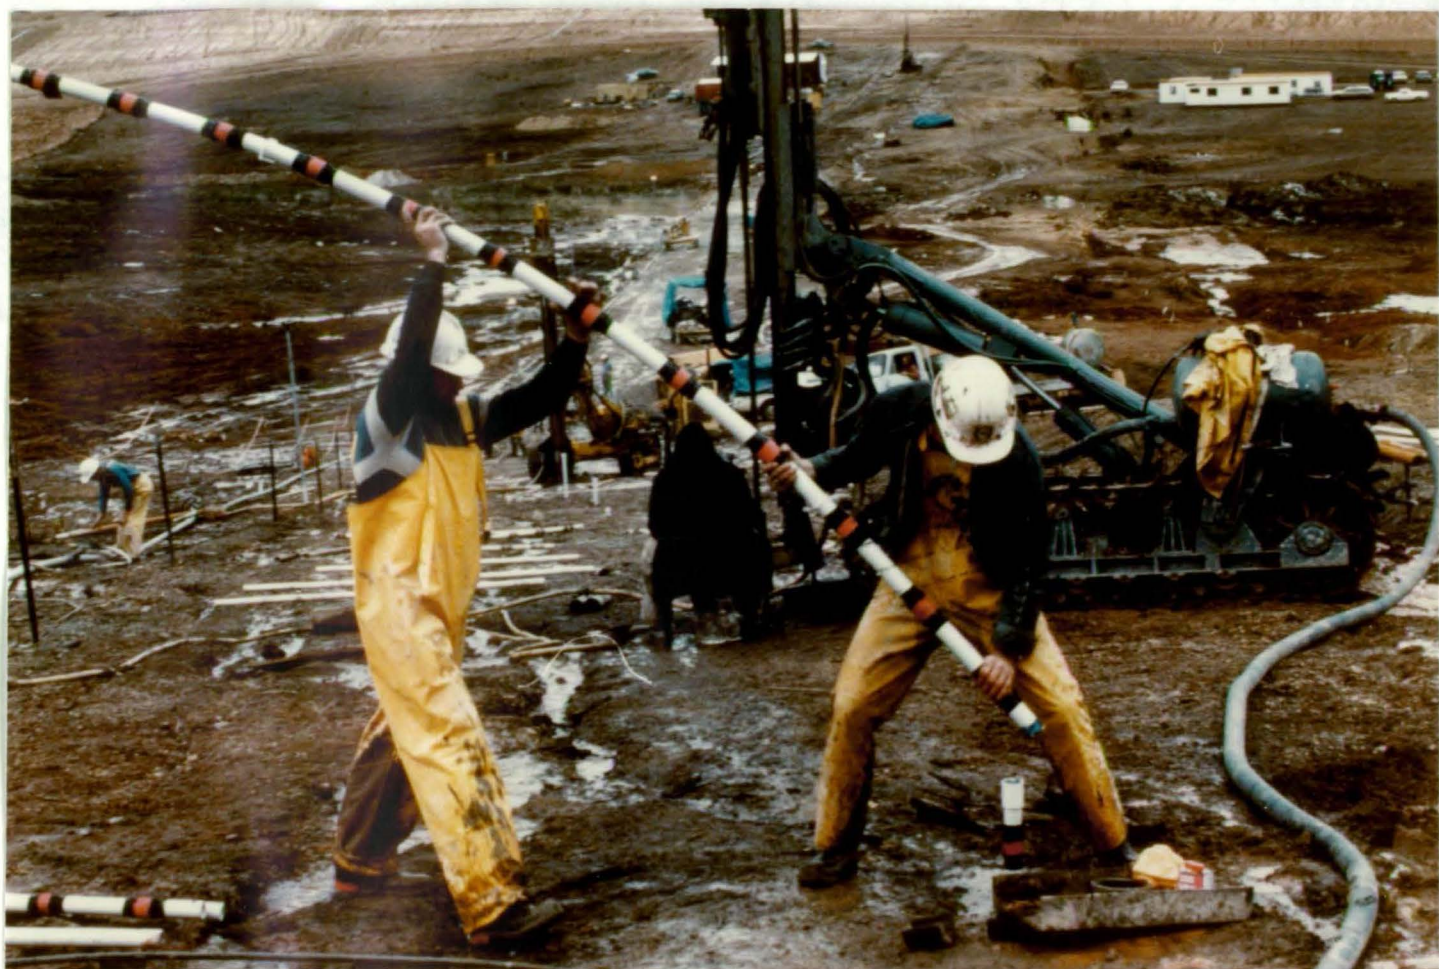
Installation of tubes a manchette for foundation grouting  
at the Refinery Catchment Lake Dam, Worsley Alumina  
Refinery, 1981.

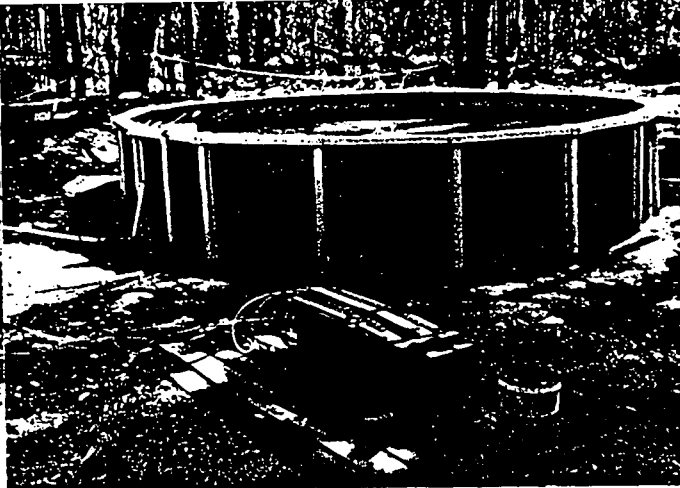
LARGE SCALE PERMEABILITY TEST OF HIGH POROSITY SURFACE SOILS IN BAUXITE RESIDUE AREA.

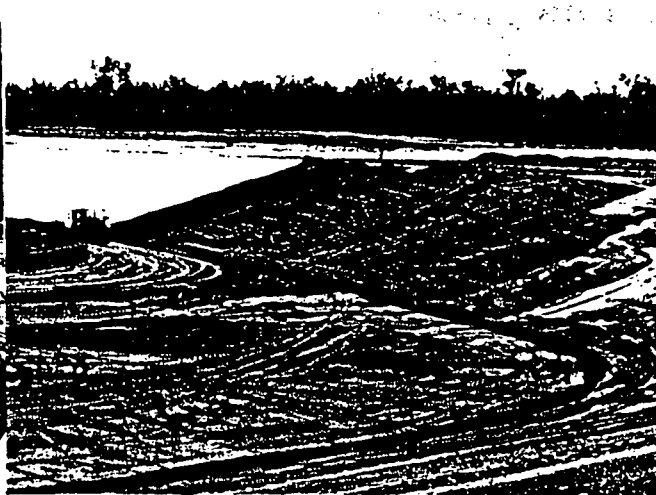
COVERING THE PVC LINER WITH PROTECTIVE SAND IN SOLAR EVAPORATION POND.

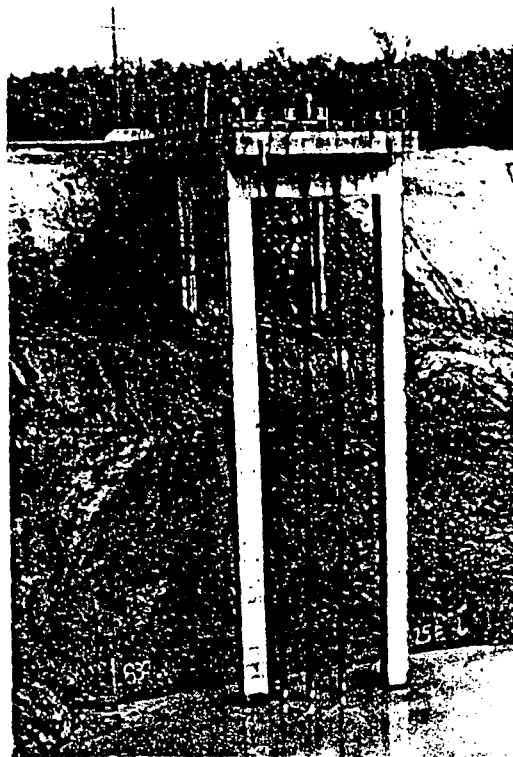
PUMP STATION MOUNTED FROM SIDE  
OF QUARRY IN FRESH WATER LAKE.  
THREE VERTICAL TURBINE PUMPS.

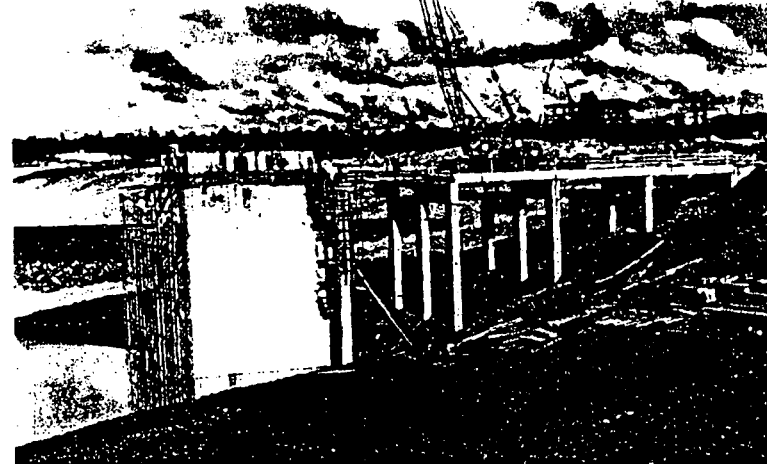
COOL WATER INTAKE & PUMP STATION IN REFINERY  
CATCHMENT LAKE.  
CONTAINS 8 VERTICAL TURBINE PUMPS.

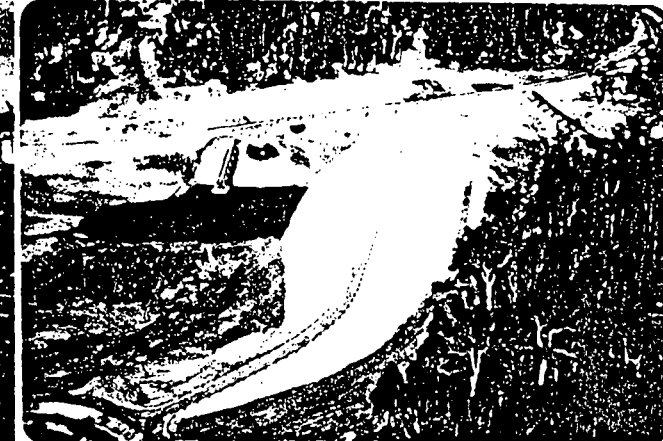
PIPEHEAD DAM WITH BYPASS CHANNEL  
AND DISSIPATOR AT REAR.  
FLOATING PUMP STATION IN POND.

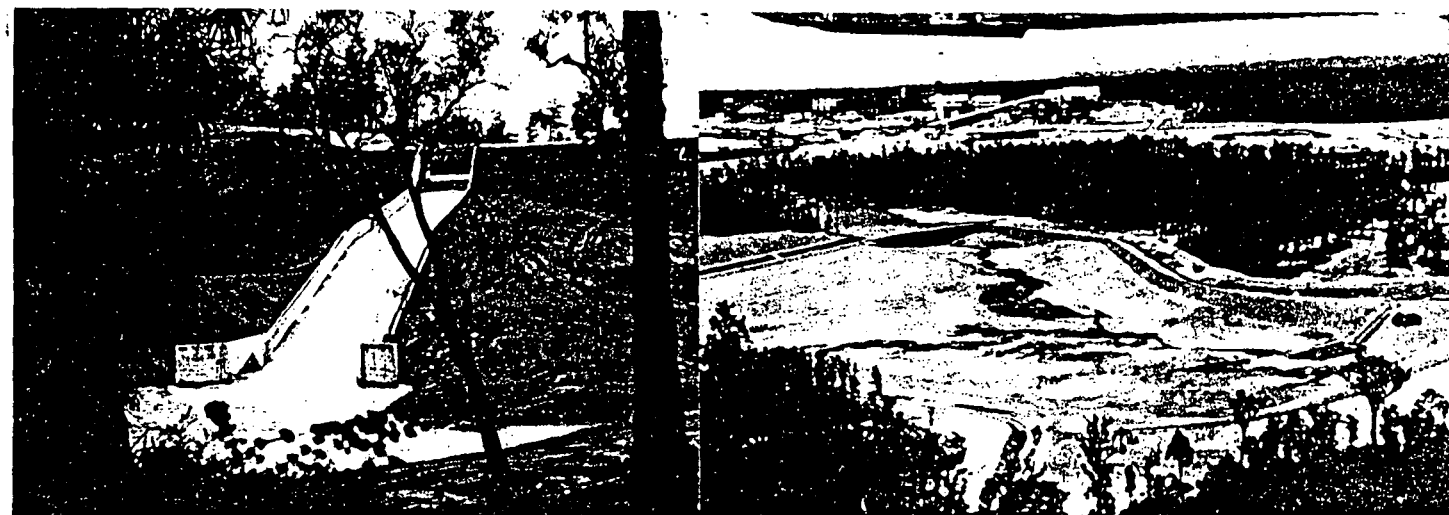
SPILLWAY TO FRESH WATER LAKE. FLOOR OF  
CHUTE IS CONTINUOUS CONCRETE WITHOUT  
JOINTS.
